ANALYSIS OF ROAD PAVEMENT BEARING COMFORT THROUGH DATA COLLECTED BY SMARTPHONE AND SERVICIBILITY VALUES

Lucas de Almeida ^{1*}, Francisco Heber ²

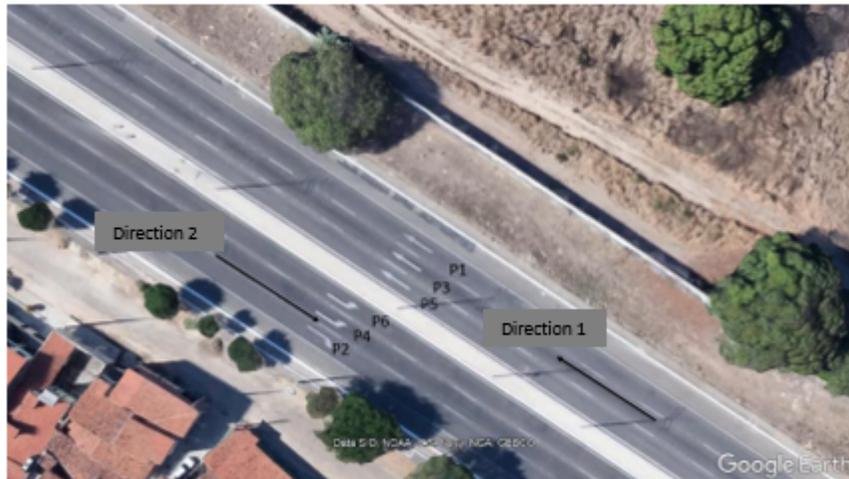
Figure 2 Section of Highway CE-501

The section in analysis corresponds to a segment of the Highway CE-501, in the city of Fortaleza, state of Ceará, Northeast of Brazil. The segment has a 4.2 km of extension in Asphalt Concrete (AC), executed between 1997 and 1998, with moderate urban traffic composed mainly of buses and private cars. The highway has undergone numerous corrective maintenance interventions throughout its operation, especially with cover-hole services. The composition of traffic for the year 2019 can be seen in Table 2 according to Lira (2019).

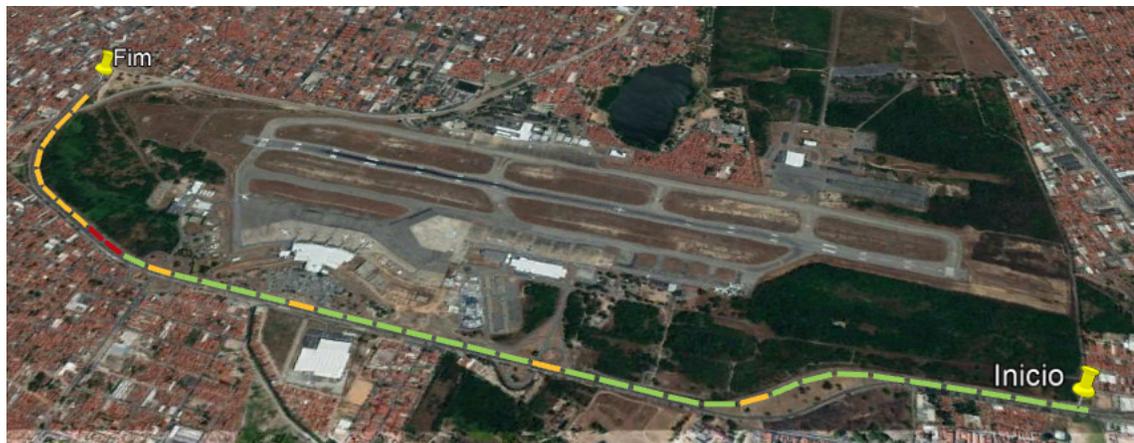
Figure 3 Map generated by SmartIRI on Highway CE-501

The application used in the survey, SmartIRI, issues a report in a file generated in .kml format (Figure 3) that allows the user to view the monitored segment by mapping the section every 100 m in a color scale associated with IRI parameters, according to Table 4.

It was observed in Figure 3 that, at the end of the analyzed section, high IRI values were detected, indicating poor traffic conditions, with cracks and patches, as shown in Figure 4.

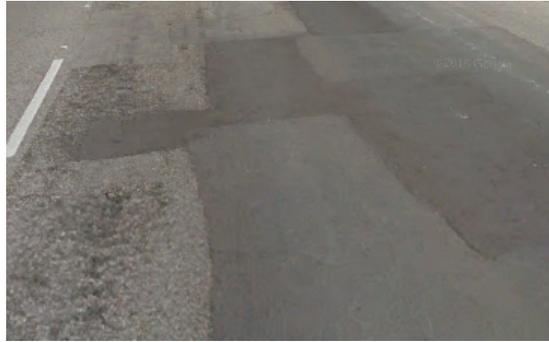
Figure 4 Detail of the end of the section of Highway CE-501

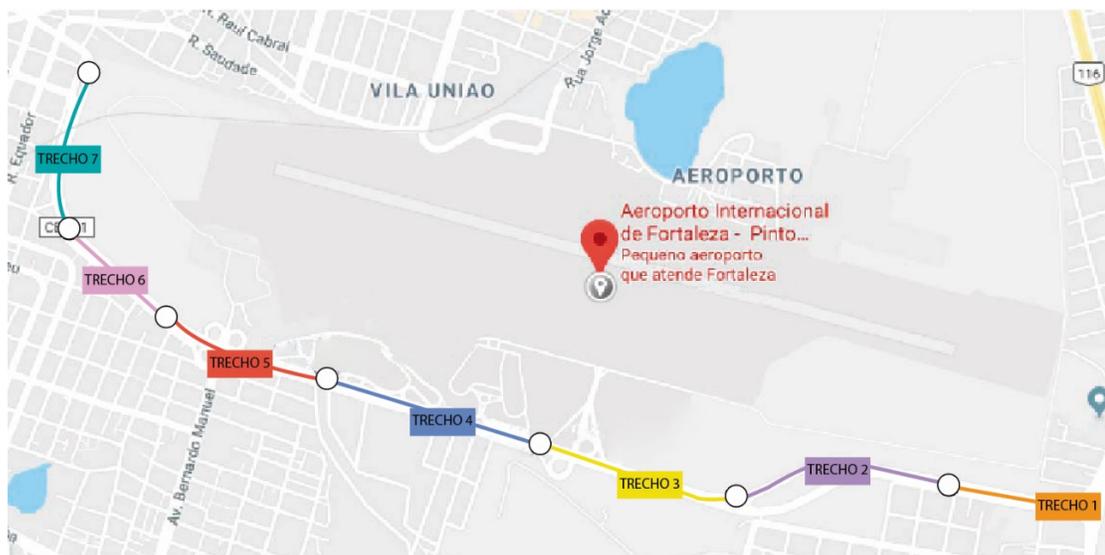
Figure 8 Indication of the sections of Highway CE-501

Table 11 and Figure 8 show the summary of the survey and the qualitative classification of each index in the P3 traffic band. It should be noted that the measurements are qualitatively correlatable.
